Balliemeanoch Pumped Storage Hydro

Environmental Impact Assessment
Report

Volume 5: Appendices
Appendix 11.1 Walkover and
Water Quality Results

ILI (Borders PSH) Ltd

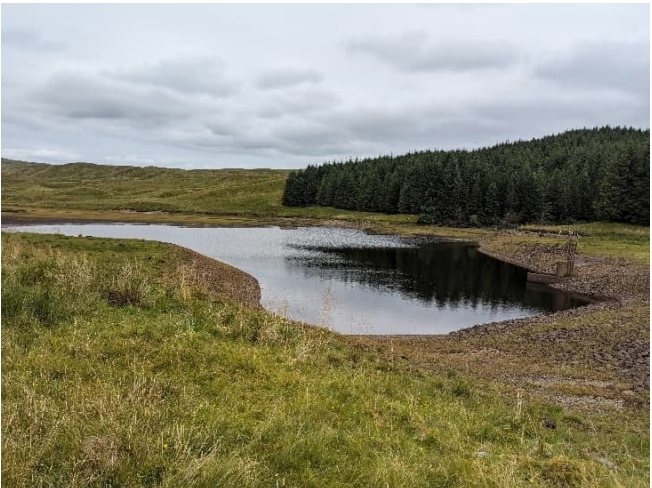
Sampling Location	Description	Photo
<p>LochA</p>	<p><i>Beochlich</i></p> <ul style="list-style-type: none"> • Damned at the southwest corner. The bed of the loch is silty. Water level within the loch appeared to be low. • Water is clear with no odour. No evidence of pollution (e.g. oil, sheens or foam). • Water likely to be oligotrophic with low primary productivity.

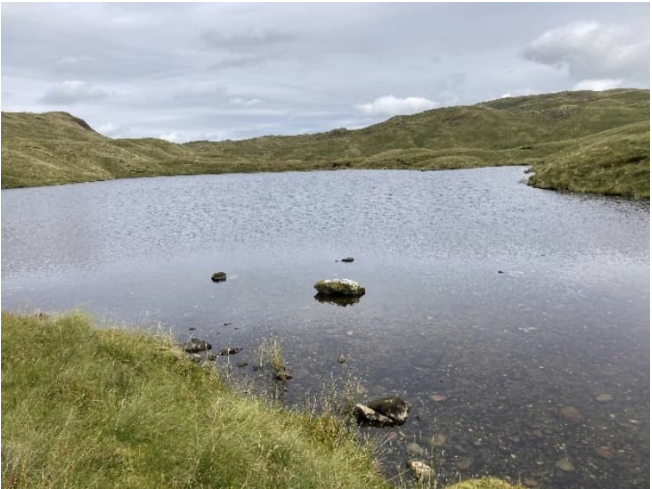
<p>LochB</p>	<p><i>Lochan Airigh</i></p> <ul style="list-style-type: none"> • Gravel and cobbles noted on the bed of the loch. • Water is clear with no odour. No evidence of pollution (e.g. oil, sheens or foam). • Water likely to be oligotrophic with low primary productivity.

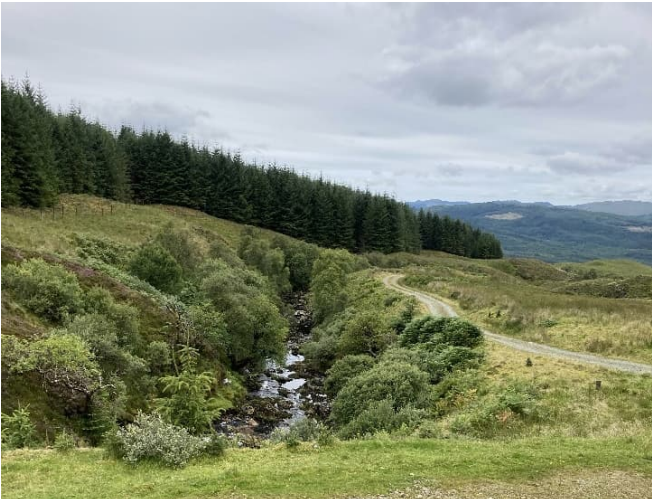
<p>RiverA</p>	<p><i>Allt Beochlich</i></p> <ul style="list-style-type: none"> • High gradient river with bedrock typology. Channel is characterised by numerous, steps and pools, waterfalls and rocky rapids. Some deposition of gravel and cobbles within the channel. • Water is clear with a slight brown tinge reflecting humic acids leached from the peaty soils, with no obvious evidence of water pollution (e.g. odour, oil sheens, foams etc.).

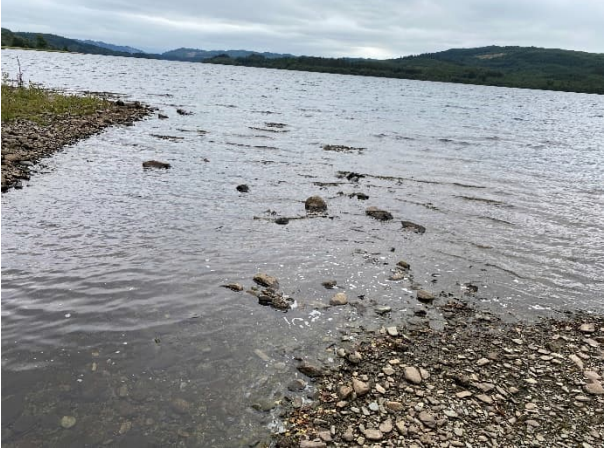
Description	Photo
<p><i>Loch Awe</i></p> <ul style="list-style-type: none"> • Photo was taken where Allt Beochlich enters Loch Awe. • Large loch with deposition of pebbles and cobbles along the beach

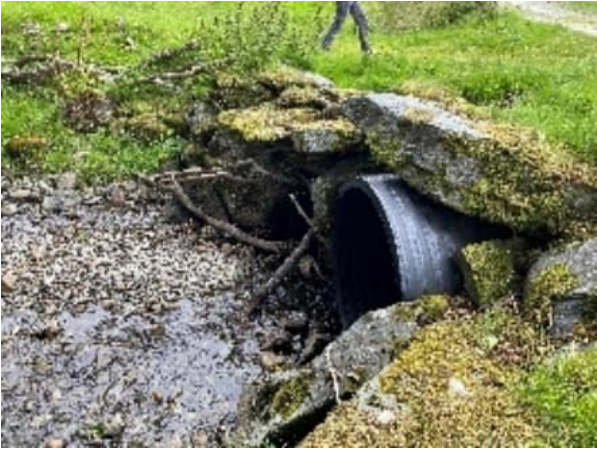
<p><i>Allt a' Gheataidh</i></p> <ul style="list-style-type: none"> • High gradient river with bedrock typology. Some deposition of gravel and cobbles within the channel. • Water is clear with a slight brown tinge reflecting humic acids leached from the peaty soils, with no obvious evidence of water pollution (e.g. odour, oil sheens, foams etc.).

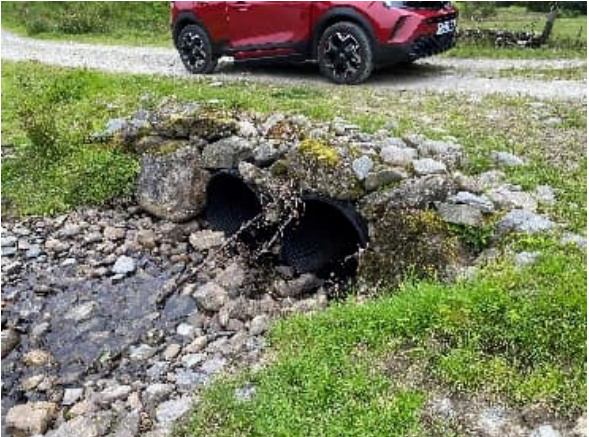
<p><i>Allt a' Chroisaid</i></p> <ul style="list-style-type: none"> • High gradient river with bedrock typology. Some deposition of gravel and cobbles within the channel. • Water is clear with a slight brown tinge reflecting humic acids leached from the peaty soils, with no obvious evidence of water pollution (e.g. odour, oil sheens, foams etc.).

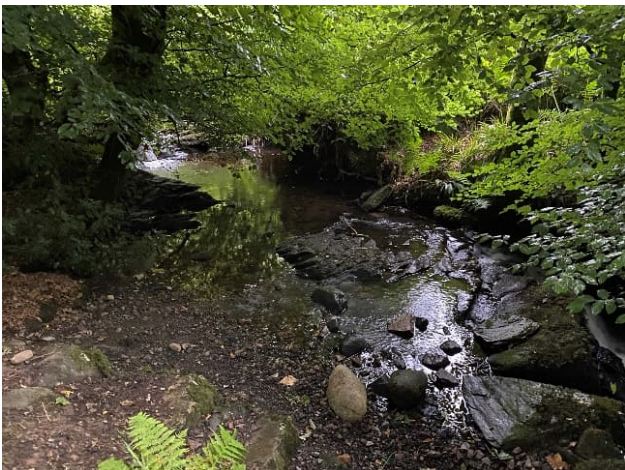
Description	Photo
<p><i>Claddich River</i></p> <ul style="list-style-type: none"> • Wide River with deposition of gravel, cobble and sands within the channel. Some evidence of underlying bedrock. • Water is clear with a slight brown tinge reflecting humic acids leached from the peaty soils, with no obvious evidence of water pollution (e.g. odour, oil sheens, foams etc.). 	 
<p><i>Crom Allt</i></p> <ul style="list-style-type: none"> • River with a bedrock typology and some deposition of gravel and cobbles within the channel. • Water is clear with a slight brown tinge reflecting humic acids leached from the peaty soils, with no obvious evidence of water pollution (e.g. odour, oil sheens, foams etc.).
