Balliemeanoch Pumped Storage Hydro

Environmental Impact Assessment
Report

Volume 5: Appendices
Appendix 6.4: Mammals

ILI (Borders PSH) Ltd

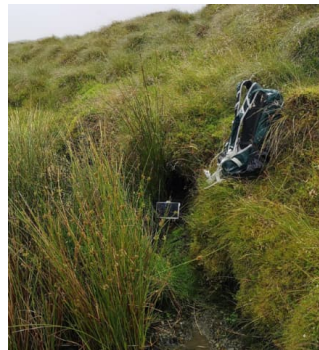
HP_OR06 (potential natal holt)

HP_OR06	Holt	Potential	17/07/2019	Next to loch behind rushes. Round hole just above water level with slide/trail to water. Single entrance. Extends back at least 70cm. No spraints at holt entrance but many present around loch.	Within the proposed Headpond.	NN 04355 16435
			18/07/2019	As before. Trail camera set.		
			25/09/2019	A second entrance had been created which showed that the chamber was a short, 1.5 m long tunnel, which was now open at two ends (as a result of the second entrance). The feature was therefore less sheltered. Numerous fresh spraints were found around the original entrance. Trail camera collected. Camera trap recorded the otter using the holt on numerous occasions between 18/07/2019 and 07/08/2019.		
			11/08/2021	As before with possible bedding within entrance and 3 fresh, 2 recent and 5 old spraints. Soft moss marker placed.		
			19/08/2021	Tunnel clear and looks frequently used. Large pile of spraints of all ages, including fresh, at original entrance. Moss marker from last visit had moved. Trail camera set.

30/09/2021	Little evidence of recent use. Moss growth and cobwebs over entrances. No fresh spraints at entrances but 10 old spraints immediately outside holt, plus one with urine stain on top of bank. Trail camera collected. Camera trap recorded the otter using the holt once between 19/08/2019 and 30/09/2019.		
			10/05/2023	Possible bedding within original entrance. Many spraints on bank. 3 m away.		
			18/05/2023	Left entrance now blocked, original right entrance open. Possible rush bedding within. Trampled grass at entrance. No spraints /odour at entrance. Many spraints nearby.		
HP_OR07	Lay-up	None	18/05/2023	Cavity under mossy collapsed bank which is open at both ends. Back is visible. One fresh / recent spraint. Very similar to HP_OR08.	Within the proposed Headpond.	NN 04179 16653
HP_OR08	Lay-up	None	18/05/2023	Cavity under mossy collapsed bank which is open at both ends. Back is visible. One fresh / recent spraint. Very similar to HP_OR07.	Within the proposed Headpond.	NN 04138 16701

Results from trail camera CT4 suggest that it was not fully effective at detecting all otter activity at holt HP_OR06. This is thought to be because this holt appeared to have a single entrance at the time of survey, but recordings showed the otter exiting the holt without entering and vice-versa. This will have caused a degree of underestimation of otter activity at this holt. In addition, a failure of the camera to record time data between 19 August and 30 September 2019 meant this data confirmed that the holt had been used in this period, and no information on the number of days / visits. However, these are considered minor limitations given the large number of recordings made and the frequent presence of spraints around the holt, the latter on its own confirming likely frequent use by otter.

Holt HP_OR06 – located on Lochan Airigh within the proposed Headpond – has the potential to be used as a natal holt, though no evidence to confirm this was ever found. HP_OR06 was identified early in the survey programme and has been subject to ongoing checks since 2019. Holt HP_OR06 was subject to camera trap monitoring in 2019, the results of which are described in the Camera trap survey section, below. In summary, an adult otter was frequently seen resting within and carrying bedding into the holt. Initially, the large number of spraints and remote location of HP_OR06 suggested it could be used for breeding. However, the altered structure of the holt for part of the monitoring period (during which a second entrance was opened), made this less likely due to the more 'drafty' and less sheltered nature of the holt. The most recent survey indicates that the second entrance is now blocked again, and it is more likely the holt could be used for breeding, though this cannot be confirmed without further monitoring.

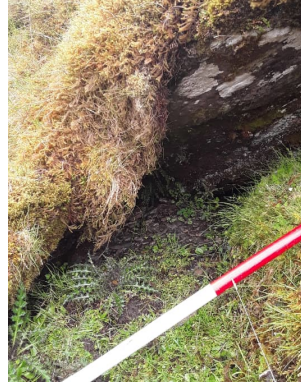
HP_OR15 (holt)

HP_OR15	Holt	None	16/05/2023	Beneath mossy rock. Dry but with two entrances. Extends about 2 m. No evidence.	Within the proposed Headpond.	NN 04760 16193
HP_OR16	Lay-up	None	16/05/2023	Large rocks which provide some shelter but no evidence.	Within the proposed Headpond.	NN 04808 16225
HP_OR17	Lay-up	None	16/05/2023	Overhanging bank with rock in front. Open at both ends. Pile of old spraints within.	Within the proposed Headpond.	NN 04955 16428
HP_OR18	Lay-up	None	18/08/2021	Covered area under overhanging bank with urine staining. One old and one fresh spraint.	Within the proposed Headpond.	NN 05071 16148
HP_OR19	Lay-up	None	16/05/2023	Dry space under overhang. One mouldy spraint.	Within the proposed Headpond.	NN 05115 16294
HP_OR20	Lay-up	None	16/05/2023	Overhanging bank with mossy rock in front. Open at both ends. One old spraint.	Within the proposed Headpond.	NN 05228 16316
HP_OR21	Lay-up	None	18/08/2021	Covered area under overhanging bank. Two old spraints.	Within access track water crossing.	NN 05461 16353

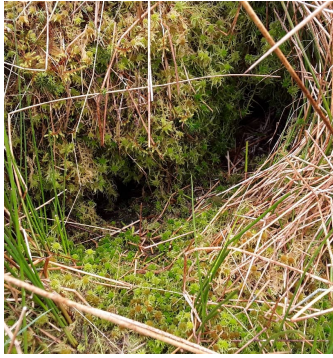
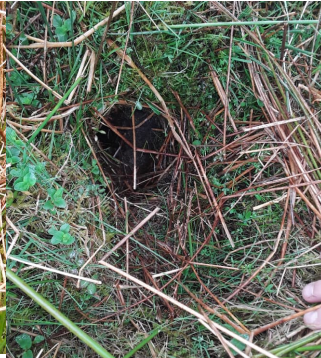
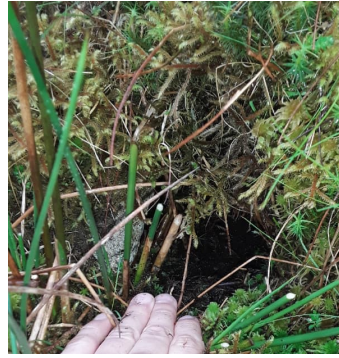
WV03

Table A-11. Photographs of water vole evidence and habitat

There is localised suitable habitat for water vole in the Moorland Zone, where evidence was found locally. Outside the Moorland Zone, no water vole evidence was found and habitat is suboptimal at best, and water voles are assumed absent. Evidence in the Moorland Zone was most reliable (i.e. with latrines/droppings) at only two locations within the Headpond area, and one at Lochan Romach. The latter was most consistent over multiple survey years, but the others did not contain evidence in some survey years or the evidence was very little. Overall, assuming all possible burrows as well as confirmed burrows (with latrines/droppings) in all survey years are water vole burrows, there are approximately 24 recorded burrows in the Headpond area (including one at the very edge), and one possible nest, at seven broad locations spread widely apart. However, at each location only some of the burrows, and in some cases none, were present in different survey years, indicating movement of an apparently small metapopulation in the Headpond area between years. Given the number of burrows, the number of water voles within the Headpond area does not appear likely to much exceed 10-20, although it is possible that some burrows have not been detected. At Lochan Romach, a count of the burrows in the same way gives approximately ten burrows, and although again the burrows are liable to vary between years, there was frequent latrine and dropping evidence here, and it is significant that the habitat here is the best seen during the surveys for water vole (particularly the deep slow-flowing outflowing watercourse with deep diggable banks and rushy vegetation). The exact locations of water vole burrows would need to be determined nearer the time of construction given variability between years.

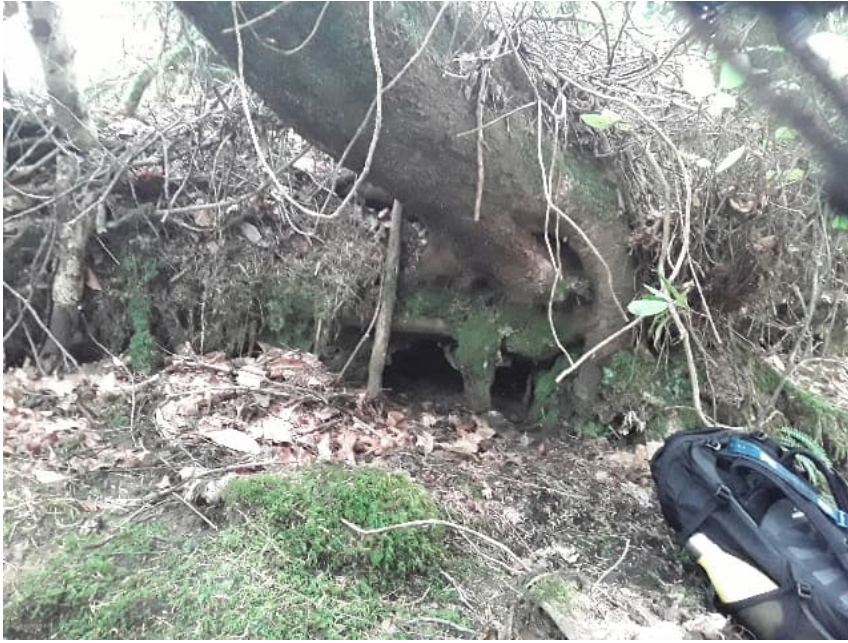
PM02 - 2023

- PM01 – a likely den within a mature oak which was identified during aerial surveys for bat roosts on 01 July 2021¹. This is adjacent to the garden where a local resident has observed pine marten. PM01 is approximately 24 m from the temporary construction compound adjacent to Loch Awe;
- PM02 – a potential den comprising a tunnel in tree roots with one very old scat. Open at both ends. Identified on 15 May 2021. PM02 is approximately 21 m from the Inveraray north-east access track.
